MONKEY SPRING FLOW MONITORING QUARTERLY REPORT (Q1 2017)

Prepared for: Hudbay
Prepared by: WestLand Resources, Inc.
Date: April 11, 2017
Project No.: 1049.91

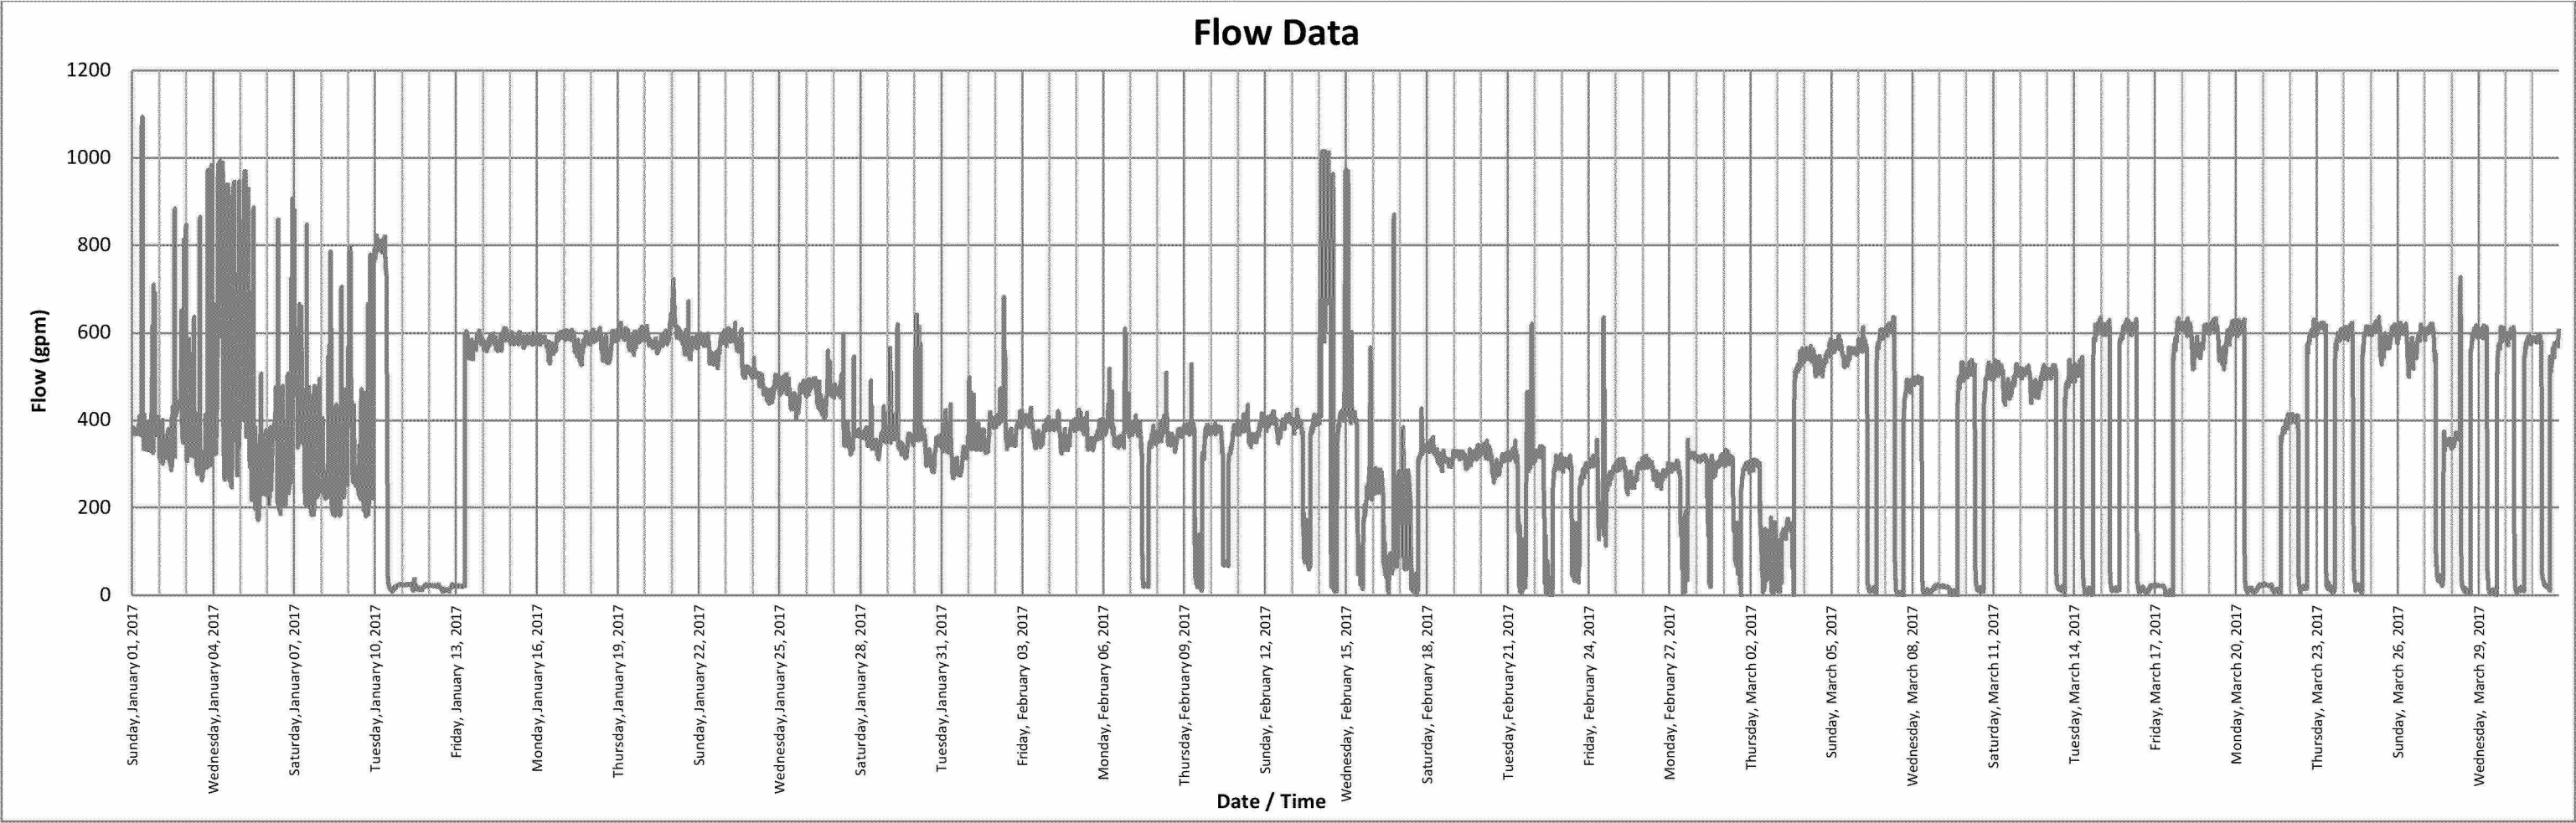
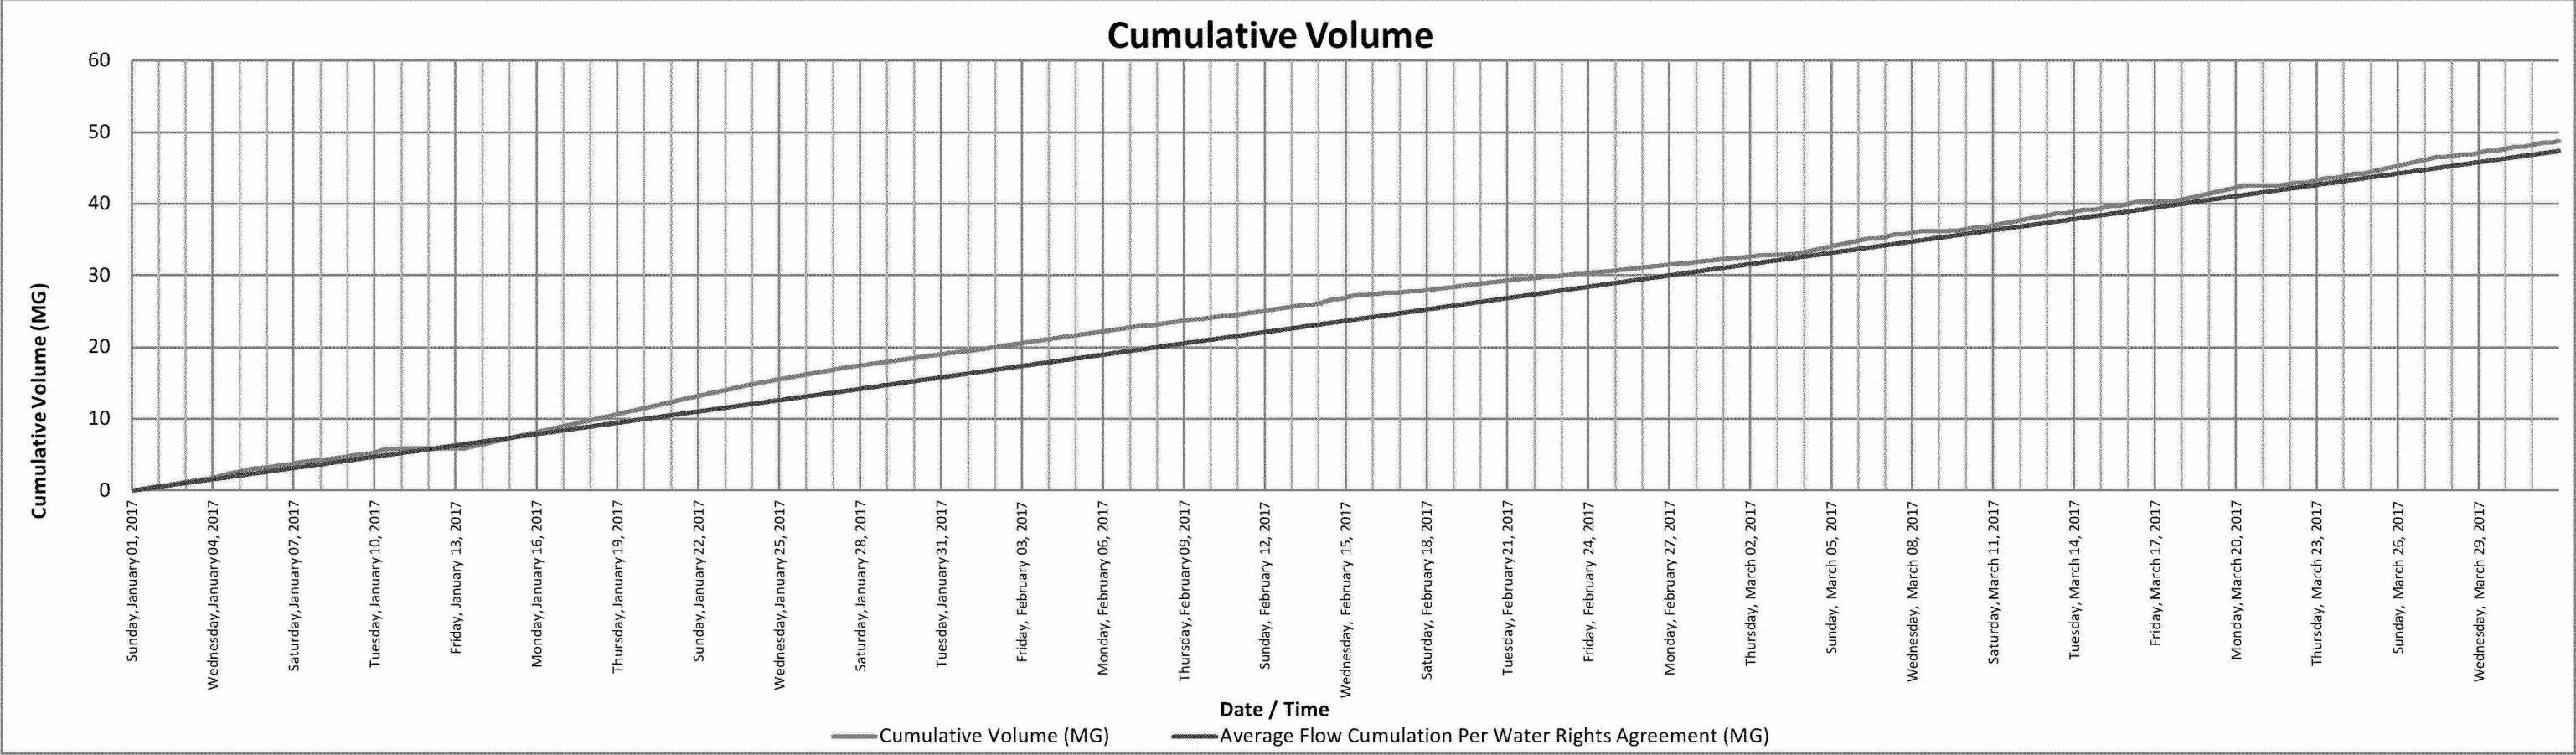
EXHIBIT I

The data in **Exhibit 1** is presented as flow over time and cumulative flow over time during the current data period (Q1 2017). The vertical gridlines on these graphs occur at midnight of each day. For this data period, oscillations in flow data ranging between 200 gpm and 1,000 gpm were observed within the first 10 days of the quarter. During a site visit on January 10th, dead Russian thistle (*Salsola tragus*) was caught in the flume and removed. It is likely that the plant material caused some of the fluctuations in flows measured within the first 10 days of the quarter.

There were approximately four times within the quarter where flow rates dropped below 50 gpm for over a 24-hr period, likely the result of diverted flows from the neighboring property. Consistent flows around 600 gpm were recorded from January 13th through January 23rd, indicating that the neighboring property was likely not diverting flow. Between late January and early March, flows decreased to around 400 gpm with some flow spikes of up to 1,017 gpm recorded around February 14th. During February and March, extreme losses in flow appeared to occur during the daytime hours of 9:00 am to 3:00 pm on weekdays (Monday through Friday). During the month of March flows averaged between 300 gpm and 400 gpm.

resulting in an excess of 1.418 MG (4.35 acre-ft). This comparison is represented graphically over time in the lower graph of **Exhibit 1**.

Eighteen (18) collected data points were excluded from the data set due to abnormally high readings. The maximum flow that the installed 12-inch 45° SRCRC Trapezoidal Flume can accommodate is 2,766 gpm at a water level of 1.21 feet. The eighteen excluded data points showed flows near or above this maximum, without a gradual rise in flow, indicating that something may have been temporarily caught in the flume, blocking the ultrasonic sensor. The Russian thistle cleared from the flume on January 10th could have contributed to the large fluctuations in flow readings within the first 10 days of the quarter; however, the measurements rarely exceeded 1,000 gpm and were therefore not excluded. The flume was thoroughly cleaned and calibration tests were conducted to ensure proper operation. This was the first time that a blockage of the flume had been witnessed firsthand. Although blockage is rare due to the open design of the flume, it is possible for debris to become lodged and produce inaccurate readings.

- During Q1 of 2017, there was a set of unusually high flow recordings which likely indicates some temporary clogging of the flume, possibly from the Russian thistle in the beginning of January. The uncommon data points do not significantly alter the overall volume of water being recorded; however, those points that reached or exceeded the maximum flow limit for the flume of 2,766 gpm were removed from the recorded data and flow totals. The flume will continue to be monitored and cleared of any obstructions every three months.
